# Case Studies

## Guidance for Refuge Area Selection

# Xenia Senior High School

# St. Augustine Elementary School and Gymnasium

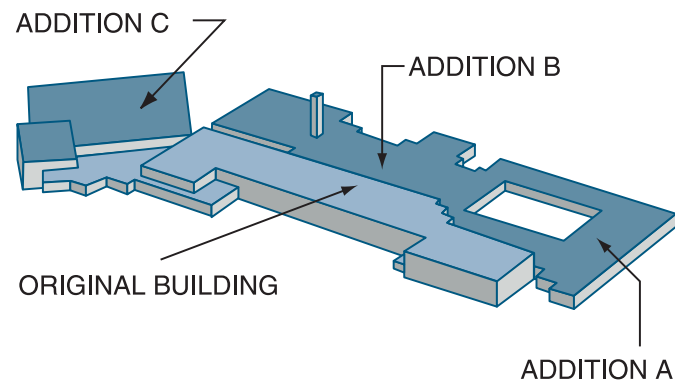
Figure 3-2 Xenia Senior High School, Xenia, Ohio.

The tornado passed directly over the school, engulfing the entire building and the adjacent fieldhouse to the south (Figure 3-2).

The enclosure walls failed on the west and south sides, allowing the winds to enter the building. The roofs collapsed over the three large spans—the auditorium, the boys' gym, and the girls' gym. The lightweight roof over the original two-story building was torn off by the extreme winds.

All **windows** on the west and south sides were blown into the interior. The high single-story, **loadbearing masonry walls** of the **long-span** rooms failed, allowing the roofs to fall in. The unbaffled west entrances allowed the east-west corridors to become **wind tunnels**.
